NASA
Technical Memorandum 106901

Transmission Diagnostic Research at NASA Lewis Research Center

J.J. Zakrajsek and D.P. Townsend
Lewis Research Center
Cleveland, Ohio

Prepared for the
Second International Conference on Gearbox Noise, Vibration, and Diagnostics
sponsored by the Institution of Mechanical Engineers
London, England, November 16-17, 1995

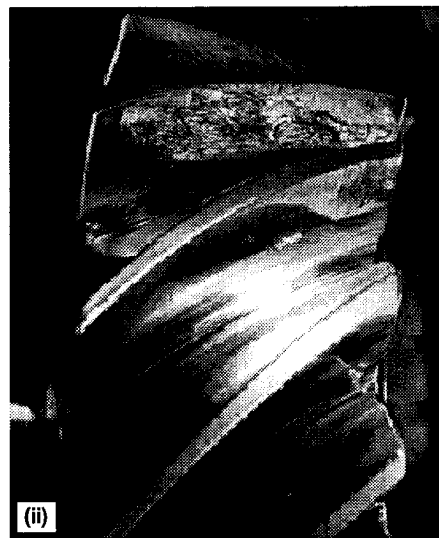
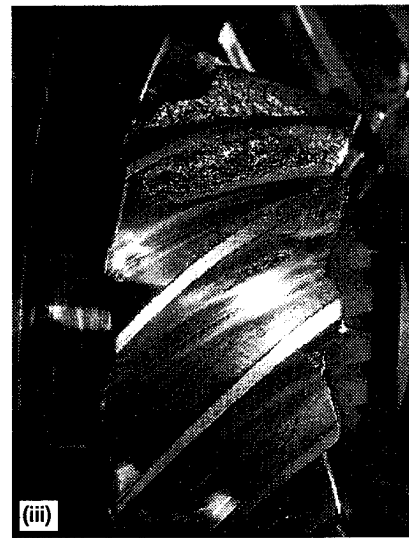
Figure 1.—(a) Sample of pitting damage on spur gears (spur gear test #2). (b) Spiral pinion damage at various times during spiral bevel fatigue test #1. (i) At $t = 5.5$ hr. (ii) At $t = 12.0$ hr. (iii) At $t = 17.79$ hr (end). (c) Sample of pitting and tooth fracture damage on face gears (face gear test #5).

There are a total of four spur gear fatigue test rigs that have been operational since 1972. The primary purpose of these rigs is to study the effects of gear materials, gear surface treatments, and lubrication types on the surface fatigue strength of aircraft quality gears. The test gears are run offset to maximize contact stress while maintaining an acceptable bending stress. Vibration data from an accelerometer mounted on a bearing end plate was captured on a personal computer with an analog to digital conversion board. The test gears are standard spur gears having 28 teeth and a pitch diameter of 88.9 mm (3.50 in.). The gears were loaded to 74.6 Nm (660 in-lb) at an operating speed of 10 000 rpm. Figure 1a shows a sample of the heavy pitting damage found on a gear tooth surface at the end of a test on the spur gear rig. A total of five tests on this rig were monitored and recorded for gear diagnostics research. The primary mode of failure on all five tests was surface pitting, ranging from light and moderate pitting on a single tooth to heavy pitting and spalling over a majority of the gear tooth surface on a number of teeth.

rig for diagnostic studies is extremely relevant, since spiral bevel gears are used extensively in helicopter transmissions to transfer power between intersecting shafts. Vibration data from an accelerometer mounted on the pinion shaft bearing housing was captured using a personal computer with an analog to digital conversion board. The 12-tooth test pinion, and 36-tooth gear have a 25.4 mm (1 inch) face width, and a 90 degree shaft angle. The pinion transmits 537 kW (720 Hp), at a nominal speed of 14 400 rpm. Two complete fatigue tests were recorded and documented on this rig. Figure 1b illustrates the damage on the pinion at three distinct times during the first fatigue test. As seen in figure 1b-i, a small pit was first seen on the pinion when the rig was shut down at 5.5 hours. The damage spread to cover more than 75% of the tooth at 12 hours, as seen in figure 1b-ii. At the end of the test, 17.79 hours into the run, the damage covered the majority of three adjacent teeth, with one tooth experiencing a partial tooth fracture, as seen in figure 1b-iii. The second fatigue test exhibited a similar failure pattern, with damage starting with a small pit on one tooth, growing to extensive pitting damage over five consecutive teeth on the pinion.

A spiral bevel rig, similar to the one described above, was also used to run face gear fatigue tests. The application of face gears to aircraft transmissions is part of an advanced rotorcraft transmission technology program. Face gears had never been tested at high speeds and high loads. The primary objectives of the face gear fatigue tests were to determine the load capacity and the primary failure mechanism for this type of gear. A standard 28 tooth spur gear drives the 107 tooth face gear at 19 107 rpm with 67.8 Nm (600 in-lb) of torque. The face gear/pinion mesh has an effective contact ratio of 2.1, meaning that at least two gear teeth are in contact at all times. Again, vibration data from an accelerometer mounted on the pinion shaft bearing housing was captured using a personal computer. A total of four face gear fatigue tests were monitored and recorded for gear diagnostics research. Tooth fracture and gear tooth surface pitting were the primary failure modes for all four tests. The damage ranged from pitting with partial tooth breakage on one test to severe pitting with complete tooth fracture of several teeth, as illustrated in figure 1c.

Initial verification of the model was made by attempting to simulate the vibration resulting from the pinion damage in the first spiral bevel fatigue test. Figure 5 represents the actual vibration signature from the test at 12 hours into the test (figure 5a), where pitting damage is limited to one tooth (ref. figure 1b-ii), and at the end of the test (figure 5b), where pitting damage covers three teeth, one with a partial fracture (ref. figure 1b-iii). The vibration signature in figure 5 is represented in the time domain and frequency domain, and also in the joint time-frequency domain, using the Wigner-Ville Distribution method (Shin, 1993). The joint time-frequency domain gives a comprehensive representation of the vibration signal, and provides an interactive relationship between time and frequency within the signal, allowing for phase and other changes in the signal to be highlighted.
